RADIO CONTROLS FOR GATED
PIPE IRRIGATION SYSTEMS

A MASTER'S THESIS

Department of Agricultural Engineering

1979

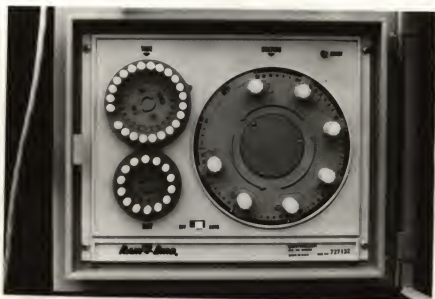
Figure 3. Front View of Controllers Showing Timers.

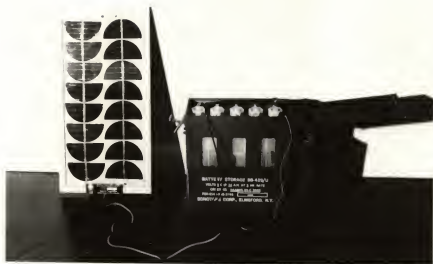
Figure 4. Ni-Cad Battery Used to Power the Receiver and Servos and Solar Panel for Re-charging the Battery.

A 4.8 volt DC, 500 mAH Ni-Cad battery was supplied with the radio control equipment to power the receiver and servo. The battery could run the receiver and servo only 16 or 10 hours depending on whether one or two servos were used. A larger battery was found that could power the equipment for more than a week. The battery was a Ni-Cad storage battery with a rating of 14 AH and was manufactured by the Sonotone Corp. of Elmsford, New York. (Figure 4).

615-D manufactured by the Solarex Corp., Rockville, Maryland, and rated at 6 volt DC and 300 mA output, were selected (Figure 4). Calculations showed that a solar panel would have sufficient capacity to run the equipment in the daylight and recharge what was used during the night.

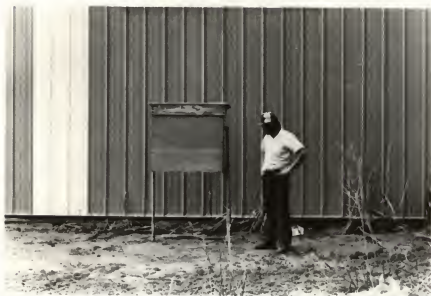
Figure 7. Plywood Box Housing the Controllers and Transmitters.

Transmitters and controllers were mounted in a plywood box installed on two pipes driven into the ground on the south side of the building (Figure 7). The controllers were mounted to the back of the box and the transmitters were mounted one on each side of the box and one in the middle. The transmitters were mounted upside down so their antennas, which were longer than the box, would extend through the bottom. This arrangement reduced the chance of moisture entering the box and damaging the electronic equipment. Theoretically the antennas should have been located one wavelength apart (4 meters) to lessen interference between signals from the different transmitters. The actual distance between transmitters was 1.5 feet but tests showed that, although there was interference, it was not enough to hinder the signals being sent to the receivers. The power supply for the transmitters sat on top of one of the controllers (Figure 8).

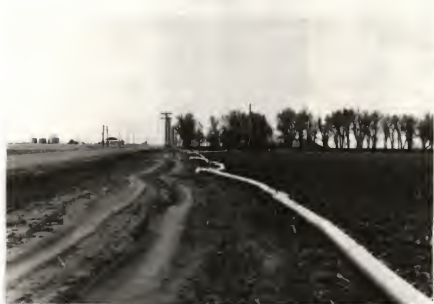
Figure 10. Gated Pipe Layed Out on the Upper End of the Field.

Gated pipe was layed out starting on the south side of the field (Figure 10). Hydrants were placed on the risers with end tees and flow control valves connected to the hydrants (Figure 11). Short segments of gated pipe were connected to the flow control valves (Figure 12). Irrigation soks, to

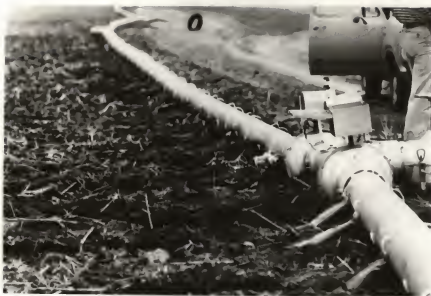
Figure 12. Segment of Gated Pipe Connected to a Flow Control Valve with Soks in Place.

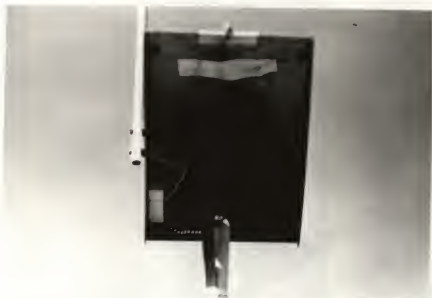
Figure 13. Receiver Mounted under Bracket Supporting the Solar Panel.

The receivers were mounted under a bracket on top of 10 foot long poles (Figure 13). This placed the receiver antenna high enough to receive the radio signals. The original wire receiver antennas were discarded and replaced with sturdy aluminum rods which were mounted to the side of the bracket. Solar panels were on top of the brackets, tilted at a 20° - 25° angle, and faced south (Figure 14). The poles were placed beside the risers and held in place by sliding them inside a larger diameter 2 foot long pipe that had been driven into the ground. The solar panels were 8 feet above the ground and the top of the receiver antennas were 11 feet above the ground.

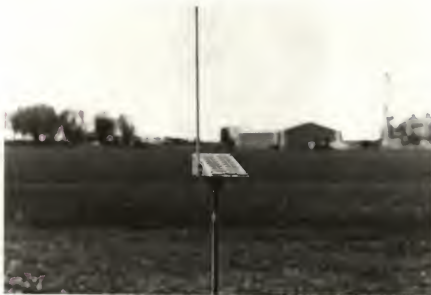
Figure 14. Solar Panel Mounted on a Bracket Supported by a Pole 8 Feet above Ground.

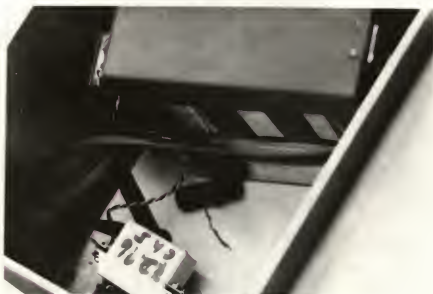
Figure 15. Inside of Flow Control Valve Box Showing the Servo and Ni-Cad Battery.

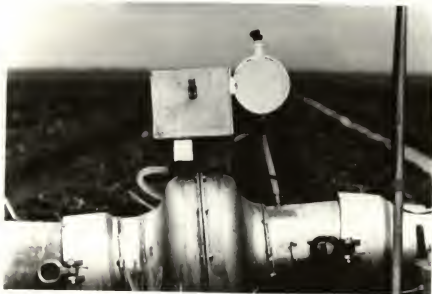
Figure 17. Three Way Slide Valve Mounted on a Flow Control Valve Located in the Field.

The 3-way valves which were mounted on the bottom side of the aluminum box were connected to the servos with a small wire rod (Figure 17). Connections to the pitot tube and diaphragm were through plastic hoses.

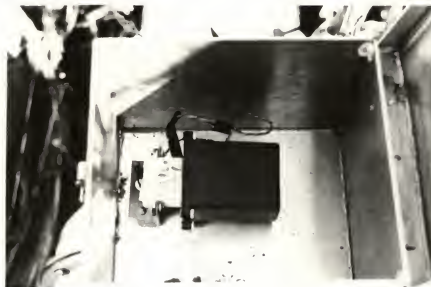
Figure 19. Modified Servo Mounted in Flow Control Valve Box.

The servos were modified by replacing the original circuit

board with a new circuit board designed and built in the Agricultural Engineering Department at Kansas State University. The new circuit board compared the incoming radio signal pulse with a standard pulse and directed the motor to turn the servo arm one way or the other. The 1500 ohm control that told the position of the servo arm to the circuit board was modified so that only the ends of the control were usable. The ends corresponded to the two extreme positions of the servo arm. As the servo arm moved to one end of its rotation, it came in contact with the 1500 ohm control end and feedback to the circuit board shut the motor off to stop the arm.

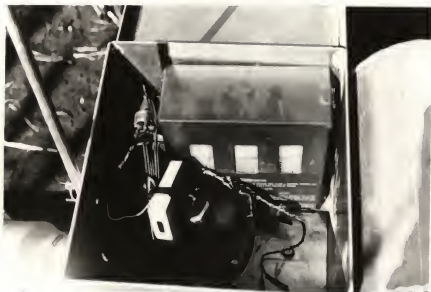
Figure 20. Flow Control Valve Box with Battery, Receiver, Servo, and Receiver Antenna.

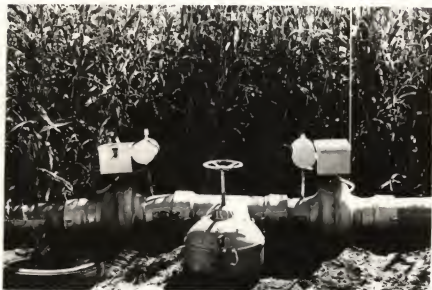
Figure 21. Hydrant and Flow Control Valves without a Solar Panel and Receiver Antenna Mounted on Flow Control Valve Box.

control valves to determine if the radio control system could operate with the antennas lowered and without solar panels. There was less damage to the servos when they were not connected to the solar panels. Without solar panels, the servos and receivers ran off large batteries which will require periodic recharging. Replacing the circuit board in the servos with low power electronic components increased the life of the battery between charges from 10 to 50 days and rebuilding the receiver with low power components could further increase the interval between charges.
